**Tecumseh**

From: North America Product Management  
 To: Wholesale and OEM Customers  
 Date: May 29, 2019 (replaces April 12, 2019 bulletin)  
 Subject: AJ Electrical Box Potential Miswiring

## REVISED PRODUCT BULLETIN

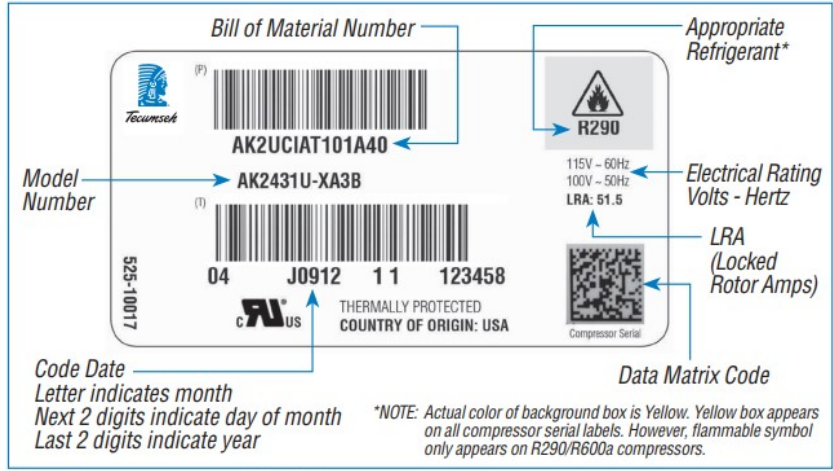
Example compressor serial label

Tecumseh has identified a potential issue with relay wiring in specific AJ electrical boxes. All AJ compressor items (shown below) utilizing the AE1170-\*\*\*\* electrical boxes have been or should be placed on hold pending evaluation and/or correction for any product date code (serial number) 1/1/2019 or later (through 3/30/19). The asterisk signifies different variants of the AE1170 electrical boxes.

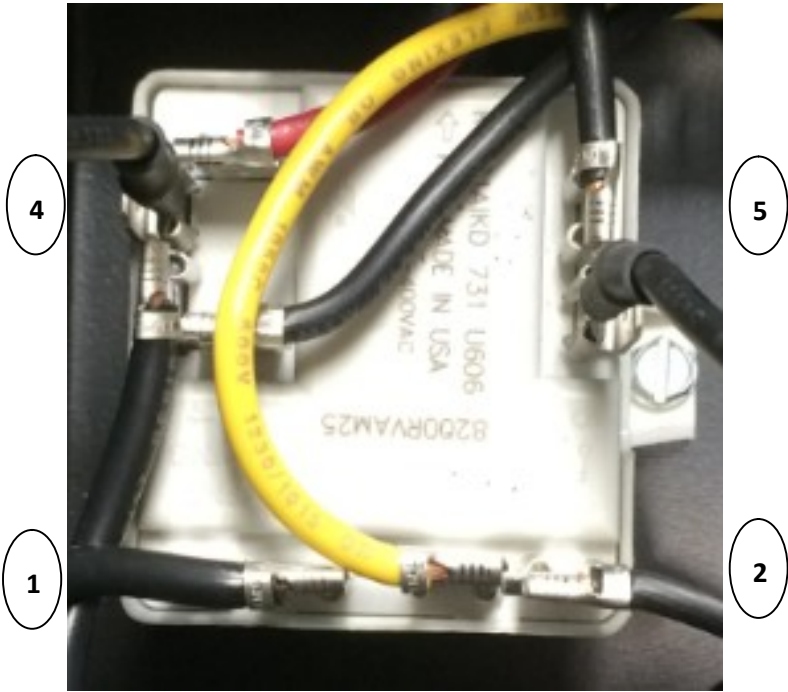
Beginning January 2019, a specific quantity of AE1170-\*\*\*\* boxes were produced using incorrect drawings where these drawings had terminal numbering not matching the physical terminal locations on the relay. Product in inventory has been quarantined and is in-process of being corrected, however, several compressors and boxes have been shipped with incorrect wiring. Condensing units are not impacted as we determined that the operator was wiring based on the physical terminal locations on the relay.

See Page 3 example of the correct wiring configuration with the yellow wire from the compressor start winding wired to terminal 2 of the Potential Relay.

- Terminal 4**
- Black wire from L2
  - Black wire from Start Capacitor
  - Black wire from Run Capacitor
  - Red wire from Compressor Run Terminal

- Terminal 5**
- Black wire from L1
  - Black wire from Overload (Compressor Common Terminal)

- Terminal 1**
- Black wire from Start Capacitor

- Terminal 2**
- Black wire from Run Capacitor
  - Yellow wire from Compressor Start Terminal

- 1) Turn off all power to the compressor or system
- 2) Remove yellow wire from terminal 1 of the Potential Relay
- 3) Connect yellow wire to terminal 2 of the Potential Relay
